# Frequency of Residential Irrigation Maintenance Problems<sup>1</sup>

Thomas R. Olmsted, Michael D. Dukes, and Bernard Cardenas<sup>2</sup>

1. This document is AE472, one of a series of the Department of Agricultural and Biological Engineering, UF/IFAS Extension. Original publication date January 2011. Reviewed April 2020. Revised August 2024. Visit the EDIS website at <https://edis.ifas.ufl.edu> for the currently supported version of this publication. © 2024 UF/IFAS. This publication is licensed under [CC BY-NC-ND 4.0](https://creativecommons.org/licenses/by-nc-nd/4.0/).

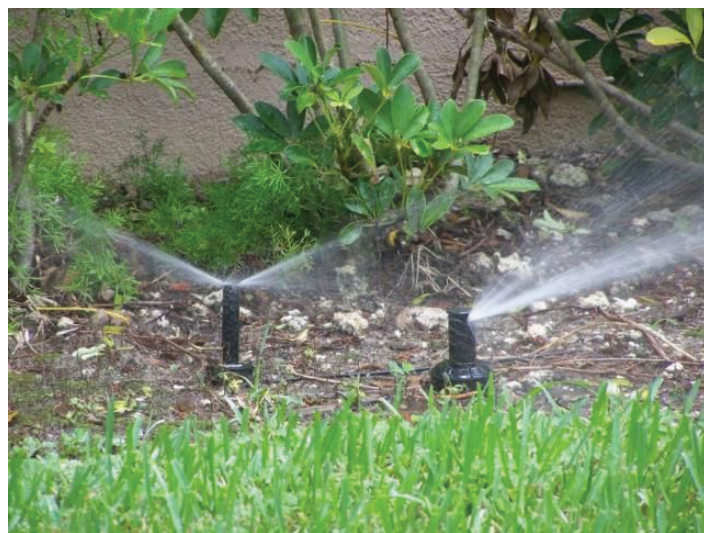
In 70% of the residential systems evaluated, the turf and landscape (ornamental beds) areas were irrigated by the same zone. This means that ornamentals and turfgrass are irrigated simultaneously because an irrigation zone covers both types of plant material (Figure 1). In most cases, ornamentals need less frequent irrigation than turfgrass. If the zone is programmed with a run time for the water requirement of the turfgrass, the result could be over-irrigation of the ornamentals.

Figure 1. Ornamentals and turfgrass being irrigated from the same irrigation zone. Note: The spray head in the background is irrigating the ornamentals and the rotary sprinkler is irrigating the turfgrass in the foreground.

How this is “fixed” depends on the severity of overlap. A few nozzles hitting the ornamentals will probably not justify

changing the system. However, if there are rotor sprinklers or spray heads designed for turf irrigation irrigating ornamental beds instead, they probably should be replaced with a lower flow-rate sprinkler or removed altogether.

On newly installed irrigation systems, this overlapping of two different plant materials should be avoided. The irrigation contractor should have the landscape plans and install the irrigation system zones according to plant type. Correcting this problem has the potential to save water, depending on how many spray heads or rotor sprinklers are removed (Table 3).

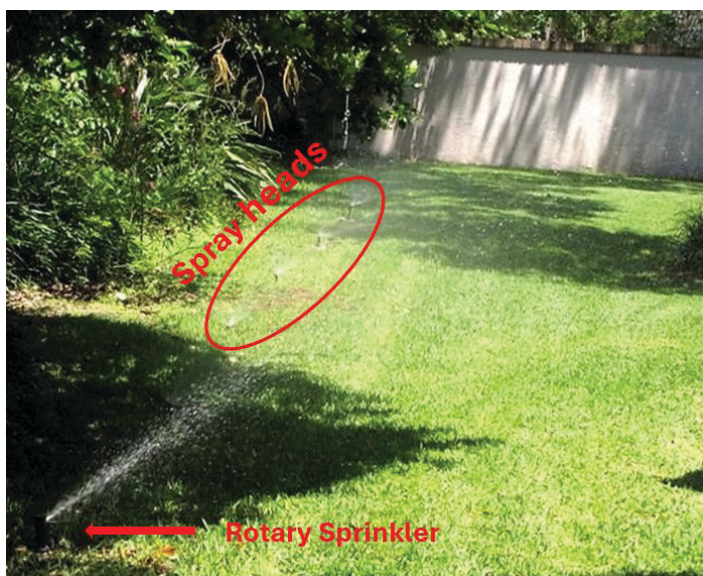
Mixing sprinkler types with different flow rates or application rates in the same zone was found to be the next most frequently occurring problem (Figure 2). For pictures of the different sprinkler types, see Ask IFAS publication CIR1421, “Operation of Residential Irrigation Timers” (<https://edis.ifas.ufl.edu/ae220>). The result of this problem could be either over- or under-irrigation of part of the zone. If the rotor or spray head has a higher application rate than designed, the plant may not effectively use the excess water. If the application rate of an individual rotor sprinkler or spray head is less than designed, the homeowner may see the area drier than the rest of the zone and increase the run time to compensate, over-irrigating the other areas of the zone.

Figure 2. Mixed sprinkler types. Note: Rotary sprinkler in foreground and spray heads in background.  
Credits: Bernard Cardenas, UF/IFAS

Unmatched application rate rotor sprinklers or spray heads can easily be fixed by changing out the incorrect nozzle and installing the correct one. The size of the mismatch will determine the quantity of water saved. Changing out the nozzles should involve only a moderate investment of time and money (Table 3).

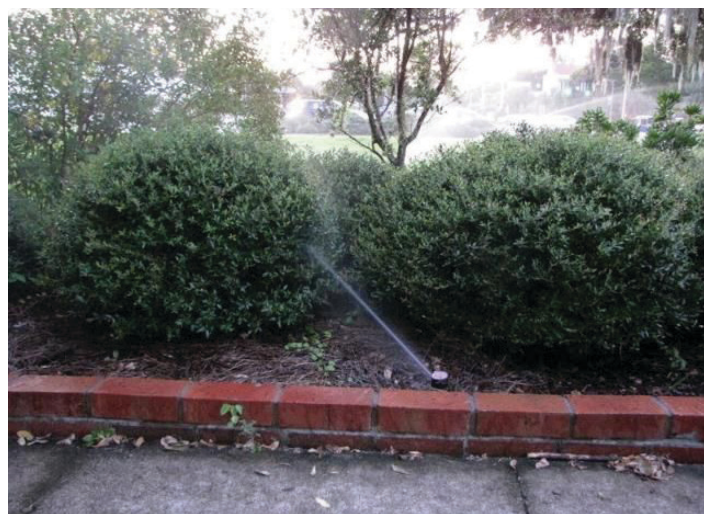
The next most often-occurring problem is the water stream from the sprinkler being deflected or blocked by vegetation (Figure 3). When the water hits vegetation close to the sprinkler, it is concentrated in certain areas and prevents spray uniformity. In older homes, either the vegetation could have grown substantially since the irrigation system installation, or the system was installed without the proper risers to clear the vegetation. If the stream of water is being blocked, then the plant material on the other side is not receiving the water the system was designed to deliver. This could stress the plant material or possibly result in an ill-advised decision to increase run times to try to compensate for the lack of water in those areas.

Figure 3. Blocked water spray.  
Credits: Bernard Cardenas, UF/IFAS

If vegetation is blocking a stream of water from a nozzle, the options to fix it include removing, cutting, or trimming the vegetation, installing a new sprinkler with a higher riser, moving or removing the offending sprinkler or spray head, or replacing vegetation in the area not receiving water with drought-tolerant plants. Any water savings after fixing the problem may be minimal and may depend on the area being blocked and the type of vegetation not receiving full coverage. If the water blockage is causing turf stress, then one of the repair options should be considered (Table 3).
