# The Role of Flow in the Everglades Landscape<sup>1</sup>

Holly E. Fling, Nicholas G. Aumen, Tom Armentano, and Frank J. Mazzotti<sup>2</sup>

1. This document is CIR 1452, one of a series of the Department of Wildlife Ecology and Conservation, UF/IFAS Extension. Original publication date August 2004. Revised June 2018 and November 2024. Visit the EDIS website at <https://edis.ifas.ufl.edu> for the currently supported version of this publication.
2. Holly E. Fling, graduate student, Duke University's Nicholas School of the Environment and Earth Sciences, Durham, NC; Nicholas G. Aumen, aquatic ecologist, Everglades National Park, c/o Arthur R. Marshall Loxahatchee National Wildlife Refuge, Boynton Beach, Florida; Tom Armentano, Ph.D., ecological consultant, Florida; and Frank J. Mazzotti, Ph.D., associate professor, Department of Wildlife Ecology and Conservation, Fort Lauderdale Research and Education Center, UF/IFAS Extension, Gainesville, FL 32611.

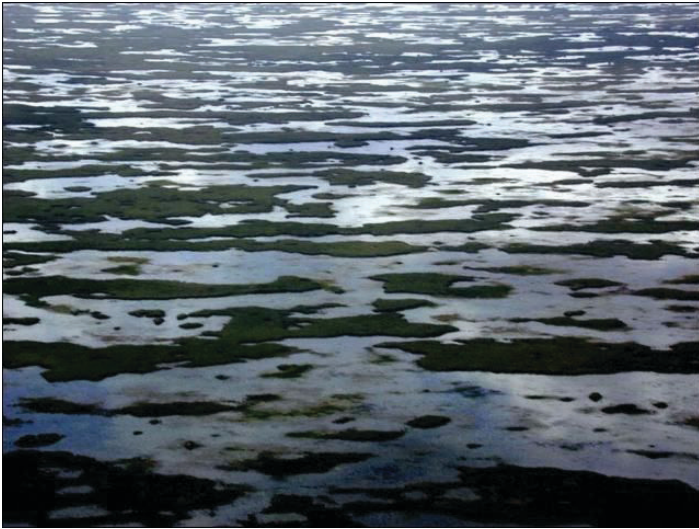
Figure 4. Well-preserved ridge and slough habitat from Water Conservation Area 3A. North is to the left, dark strips are sawgrass ridges, light areas are open water sloughs.

Loss of ridge and slough landscape is defined by the Science Coordination Team (2003) as a loss of elevation difference between ridge height and slough depths resulting in a flattening of the landscape and a loss of distinct ridge and slough vegetation growth aligning with flow direction. Early pre-drainage documentation and photographs reveal an organized pattern of congruent landscape, vegetation, and flow similar to Figure 4, while post-drainage documentation reveals a scattered, blurred, and unstructured landscape similar to Figure 5.

Loss of water flow is largely attributed to water management and development and has severely altered the ridge and slough landscape. Elongated ridges aligning with the direction of water flow are evident in Figure 4, which is consistent with pre-drainage patterns, while Figures 5 and 7 depict a degraded pattern with amorphous vegetation clusters having no directional alignment. Although some construction attempted to retain the integrity of the flow pattern using canals along the road connecting the ridge and slough landscape every 4km, the landscape has been greatly degraded. Culverts were put into Alligator Alley (I-75) to try to maintain some water flow. Redirection of water flow severely impacted the ridge and slough landscape upstream and downstream of the Alley (Figures 5 and 6).

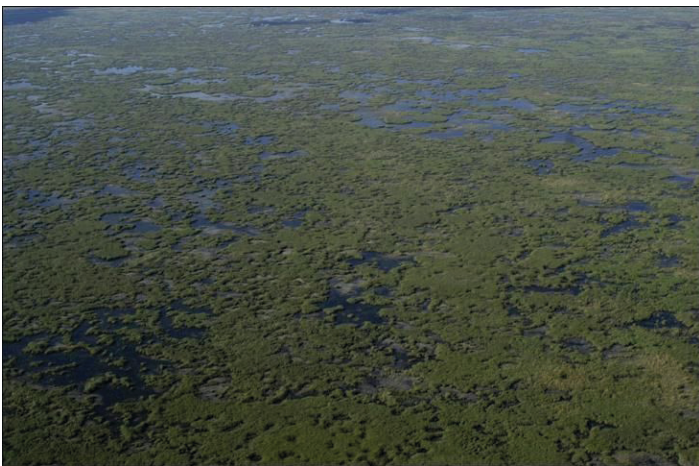
Figure 5. Current degraded ridge and slough landscape in Water Conservation Area 3A, north of Alligator Alley (I-75).
