# Powderpost Beetles and Other Wood-Infesting Insects<sup>1</sup>

P. G. Koehler, F. M. Oi, and C. A. Andrews<sup>2</sup>

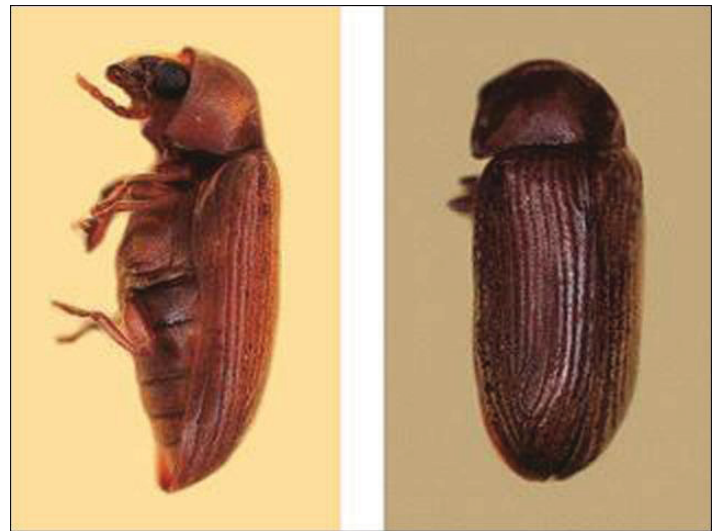
Figure 1. Anobiine powderpost beetle.

Anobiine powderpost beetles (Figure 1) are usually about  $\frac{1}{16}$  to  $\frac{1}{4}$  inch long and reddish brown or grayish brown to dark brown. The body is cylindrical, elongated and covered with fine hair. The head is covered by the pronotum from top view. The last three segments of antennae are usually lengthened and broadened. The larvae are white, C-shaped grubs with rows of small spines on the dorsal side (Figure 2). The beetles' life cycle lasts one to 10 years, depending on the species. Anobiine powderpost beetles infest seasoned softwood and the sapwood of seasoned hardwoods.

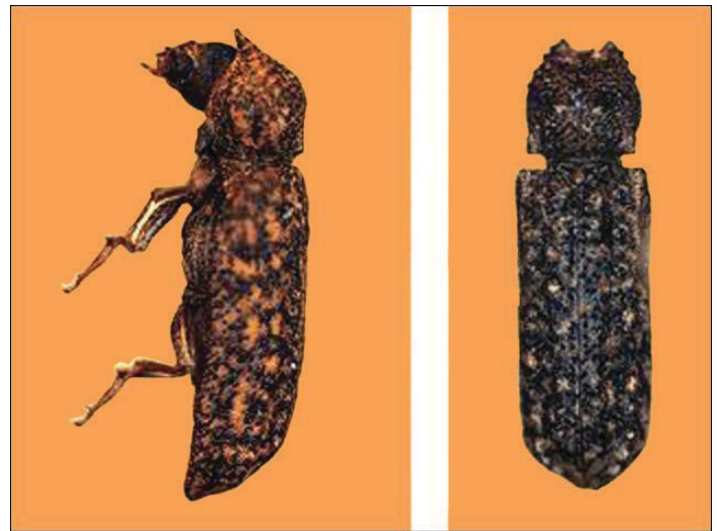
Figure 3. Bostrichid powderpost beetle.  
Credits: James Castner, UF/IFAS

Bostrichid powderpost beetles (Figure 3) are  $\frac{1}{8}$  to  $\frac{3}{4}$  inch long and reddish brown to black. Their bodies are elongated and cylindrical with a roughened thorax. Heads are concealed by the pronotum from above. The antennae are short with three or four enlarged, serrated terminal segments. The larva is white and C-shaped with no spines on the body (Figure 4). The life cycle is one year. Bostrichids infest seasoned softwood and hardwood, especially unfinished floors, windowsills, and furniture. Bamboo items are especially susceptible to attack by some species of Bostrichid beetles.

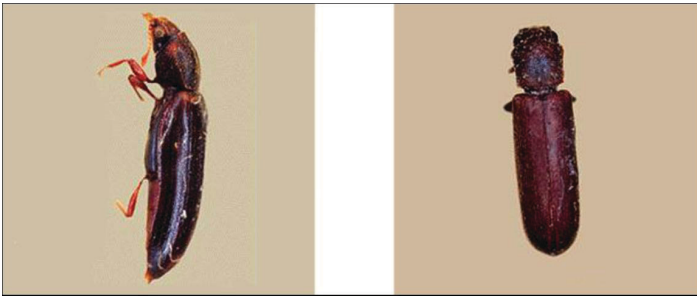
Figure 5. Lyctine powderpost beetle.  
Credits: James Castner, UF/IFAS

Lyctine powderpost beetles (Figure 5) are about  $\frac{1}{4}$  inch long and brown. The body is elongated and slightly flattened. The head is prominent and not covered by the pronotum. Antennae have a two-segmented terminal club. The larvae are white and C-shaped, with the eighth abdominal spiracle enlarged (Figure 6). This beetle's life cycle is six months to four years.

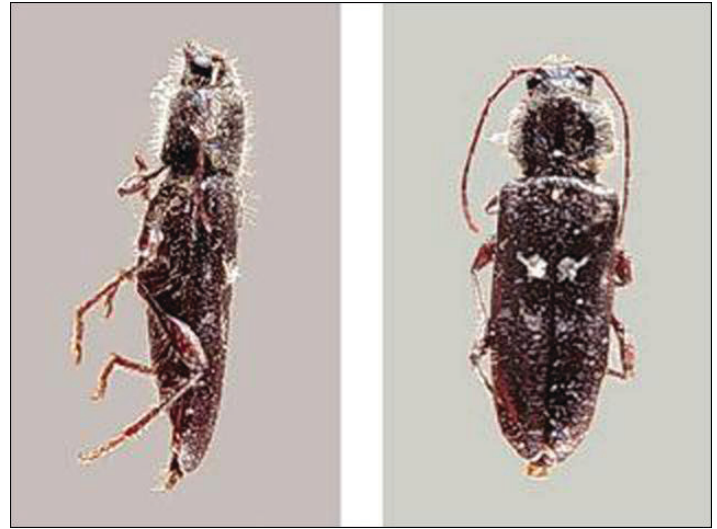
Figure 7. Old house borer adult.  
Credits: James Castner, UF/IFAS

The larvae of the old house borer (a long-horned wood boring beetle—Cerambycid) (Figure 7) sometimes infest softwoods. The adult beetle is grayish-black and  $\frac{1}{2}$  to  $\frac{3}{4}$  inch in length, with several white markings on the wing covers and with long antennae. The female lays eggs in crevices of logs or timbers. The larvae hatch and require three to five years or more to mature. The larvae are  $\frac{1}{2}$  to  $1\frac{1}{2}$  inches long and are white, segmented, and have an enlarged, brownish head (Figure 8). They bore through the wood, making irregular galleries. During quiet times, their feeding may be heard as a clicking or rasping sound. The beetles emerge through an oval hole about  $\frac{1}{4}$  to  $\frac{3}{8}$  inch in diameter.

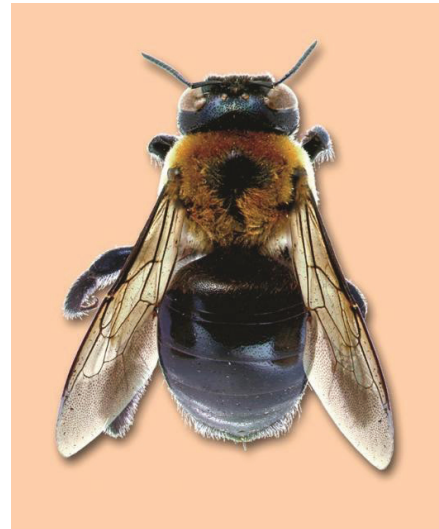
Figure 9. Adult carpenter bee.  
Credits: Paul M. Choate, UF/IFAS

Carpenter bees (Figure 9) are  $\frac{3}{4}$  to 1 inch long and closely resemble bumble bees, except that their abdomen is a shiny metallic greenish-black, and the abdomen of bumble bees is very hairy. These insects sometimes build their nests in solid wood such as weather boarding, railings, supports, and trim of buildings. Their nests are in the form of tunnels 3 to 6 inches deep in the wood. The entrance hole is about  $\frac{1}{2}$  inch in diameter. The holes are very clean and appear as though they were made by a drill.
